OPERATING EXPERIENCE SUMMARY

Office of Environment, Safety and Health

Summary 2001-09

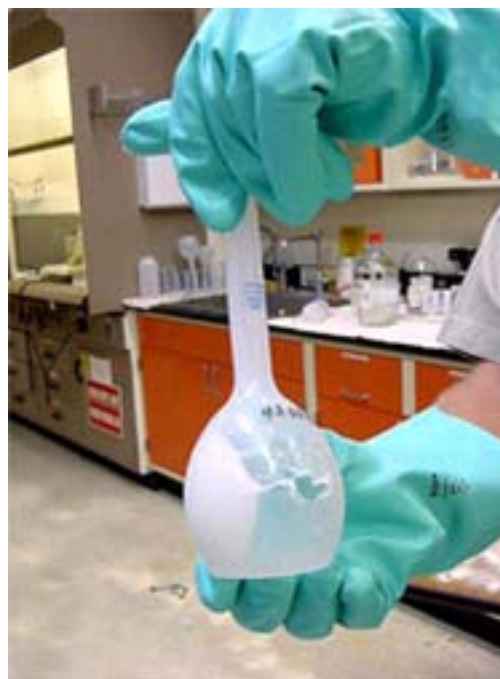
On September 14, 2001, in a laboratory in Building 4500N at the Oak Ridge National Laboratory (ORNL), a capped polymer flask containing hot concentrated sodium hydroxide ruptured (Figure 1). The highly caustic solution sprayed onto a chemist, severely burning him. The chemist had not been wearing a lab coat, gloves, or goggles, as suggested by laboratory guidance. (ORPS Report ORO--ORNL-X10NUCLEAR-2001-0029)

The chemist was working alone, performing a routine activity that had been done hundreds of times before, mixing reagents in a Nalgene flask in preparation for a controlled experiment. He knew that the sodium hydroxide solution he created was exothermic and that the flask should have been left open, but in this incident he capped the flask by mistake. The build-up of heat and pressure in the flask caused it to suddenly rupture and spray caustic solution on the chemist and parts of the laboratory. The chemist immediately rinsed himself in an eyewash/shower in the outside hallway, but later was found to have first, second, and third degree burns to his hands, face, and torso. Burns to one eye were the most serious of his injuries. An emergency crew transported him to a hospital, where he was treated and stayed two days to recover. Full recovery of his vision remains questionable.

Figure 1. Ruptured flask

Had the chemist been wearing goggles, gloves, and a laboratory coat, his injuries would have been far less severe. Laboratory guidance suggested that such personal protective equipment (PPE) be used, but there was no strict procedural requirement to do so. The contractor has yet to release the results of its investigation and recommend

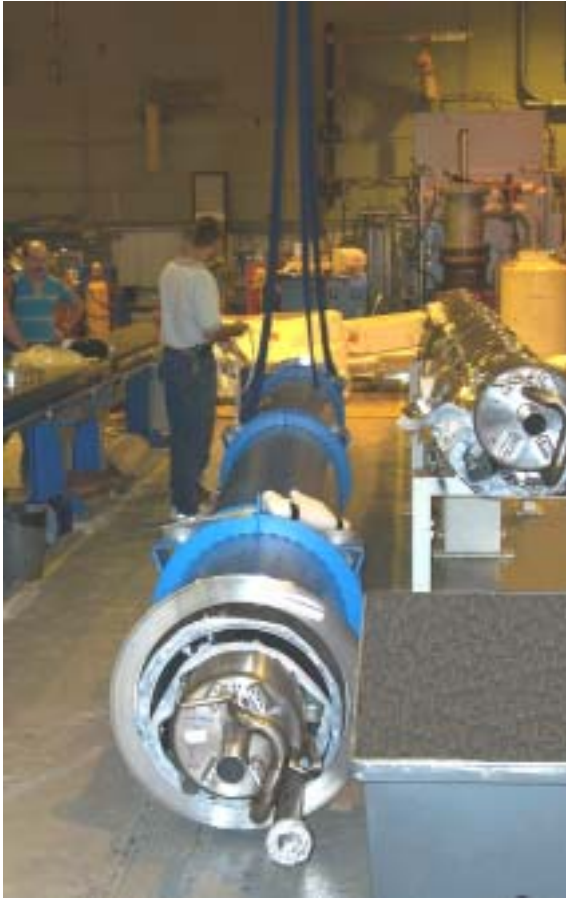
Figure 1. The magnet in its lifting slings

Riggers used a building bridge crane and two nylon composite slings, as shown in Figure 1, to lift the magnet while it was being transferred between assembly stations. The slings were purchased specifically for the program, and each was rated for a load of 21,200 pounds. The load angle for the lift was between 25 and 30 degrees, resulting in approximately 13,000 pounds of tension in each sling. The slings were rigged so that they pressed against the corners of the magnet support castings. The riggers recognized these corners as chafe points and installed anti-chafing protection that consisted of three pieces of cut-up fire hose and a piece of folded and taped polystyrene. Figure 2 shows one of the slings with a piece of fire hose being utilized as chafing protection.

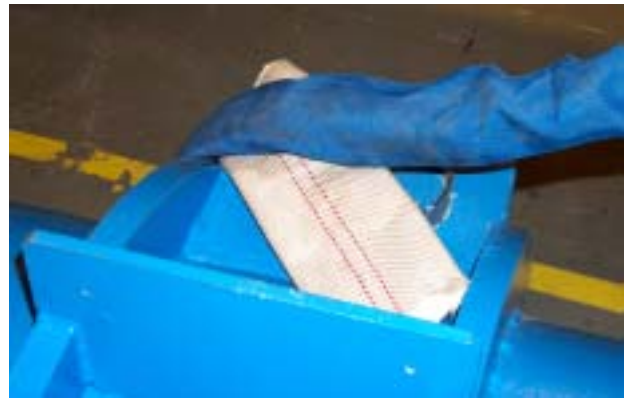
The direct cause of the event was the use of inadequate anti-chafing material that failed to protect one of the two slings from being cut by the support casting of the magnet. The three chafe points that used sections of fire hose did not experience damage to the sling at these points. The fourth chafe point that used folded and taped polystyrene packing material was cut through at the location where the sling failed. The sling requirements for rigging the magnet were properly evaluated. However, the chafing potential was underestimated. This incident could have been prevented if the work plan had properly evaluated the lift and identified adequate anti-chafing material. In addition, a straight pick, using a lifting bar fixture, could have been recommended that would have eliminated the need for a sling and anti-chafing material altogether.

Figure 2. One of the lifting slings with the piece of fire hose to protect against chafing

- Develop a divisional procedure that uses anti-chafing materials that are either commercially approved or have been evaluated by engineering as acceptable.
- Revise the Laboratory Basic Rigging Course to address material selection for chafing protection.
- Conduct a review of divisional procedures and practices and implement changes to prohibit personnel from working under suspended loads.
- Revise assembly procedures for the Large Hadron Collider magnet to use a spreader bar for lifting, to eliminate the need for slings and chafing protection.

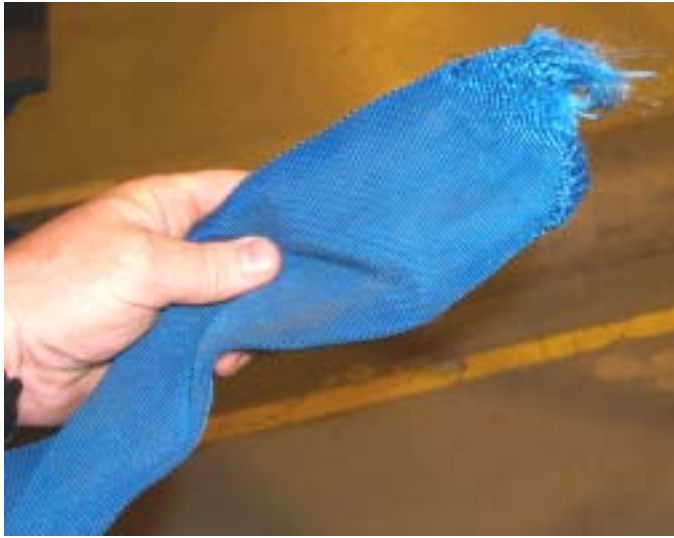
Three technicians started to install three sets of plates on the bottom of the magnet assembly, while the magnet was suspended. The sling on the east side of the magnet failed at this time (Figure 3), dropping that end of the magnet to the concrete floor and forcing the crane westward, which allowed the other end of the magnet to land on the floor. The sling failure could have resulted in a catastrophic accident because personnel were working under or near the load when it fell. A serious injury could have resulted. Investigators determined that the damage to the magnet was repairable.

Figure 3. The failed sling
